# BEDP ENVIRONMENT DESIGN GUIDE

## OFFICE BUILDING RETROFIT AT 55 ST ANDREWS PLACE, MELBOURNE – TURNING A SPARROW INTO A PEACOCK

Roger Kluske and David Clark

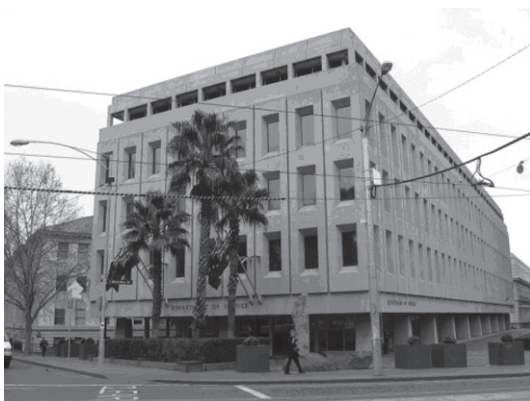
**Figure 3. 55 St Andrews Place prior to upgrade**  
(Source: Cundall, 2005)

- **Lighting** – the building was very dark due to the heavily tinted windows, and the artificial lighting system didn't meet modern lighting practices
- **Water** – there were no water conservation features in the building
- **Fire Services** – required upgrade
- **Floor Coverings** – the carpets were nearing the end of their life

- the heavily tinted glazing became very hot in summer causing localised discomfort due to radiant heat, and cracking of the glazing in a number of windows

- To increase the daylight potential, glazing to windows was replaced with clear glass, and external automated blinds were installed to levels 1 to 3 to improve thermal comfort. Most of the building's windows face east and west and receive large solar heat loads. As they were not shaded, the resultant internal heat gain required a lot of energy to air-condition. To manage the solar heat loads through the windows, the glass had been tinted and a reflective film had been applied. The windows were very dark and, consequently,

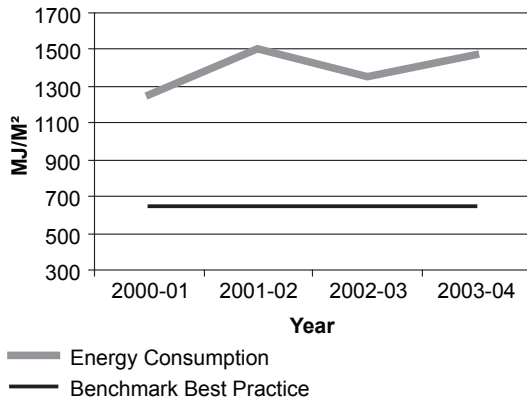
From a sustainability point of view the building was in poor condition. The energy use was high – the total electricity and gas use exceeded best practice for this type of building and it was one of the government offices’ worst performers. The building rated about 1 star in an unofficial Green Star rating (one third of the building’s points were due to its proximity to Parliament railway station!) and benchmarked, it is suggested it would have been around a 1 star rating using the ABGR (now NABERS Energy) Whole of Building rating tool.

**Figure 4. Electricity and gas consumption from the past 4 years compared to benchmark**

Compared to a benchmark of 'best practice' from the Property Council of Australia Energy Guidelines 2003. (Source: Cundall, 2005)

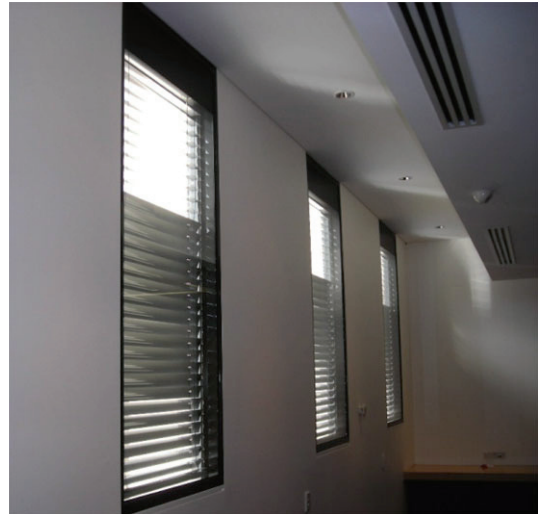
**Figure 6. Refitted windows**

Windows were clear glazed and external automated daylight guidance blinds were fitted. (Source: Cundall, 2007)

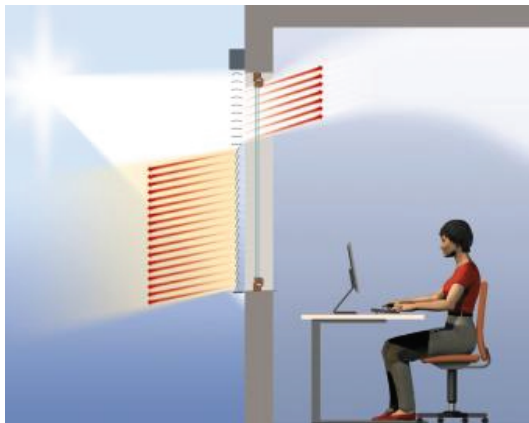
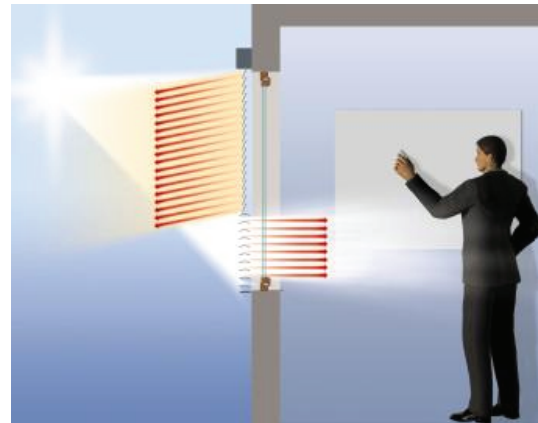
**Figure 7. External automated daylight guidance blinds**

These blinds allow for adjustment in 2 panels – allowing for glare to be avoided at desk level, and light to be reflected up to the ceiling at the same time.

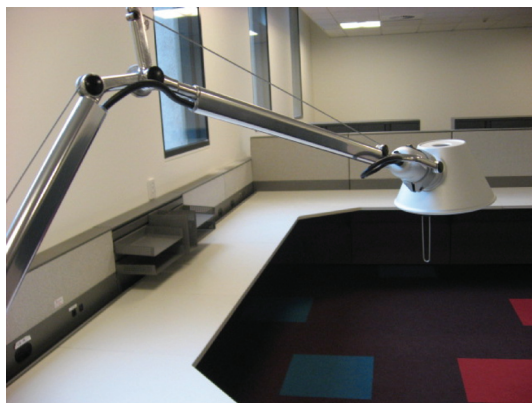
**Figure 8. Task lighting to workstations**

The task lighting is connected to the lighting control system which allows all lighting to be shut down via time clocks.

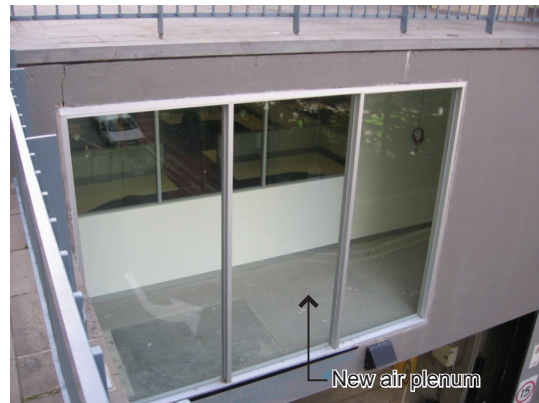
**Figure 10. New window and air plenum**  
The existing air grille was removed and the aperture glazed, with an additional glazed panel added to the internal partition. This allowed daylight to enter the room beyond, and the space between the walls to act as a plenum.

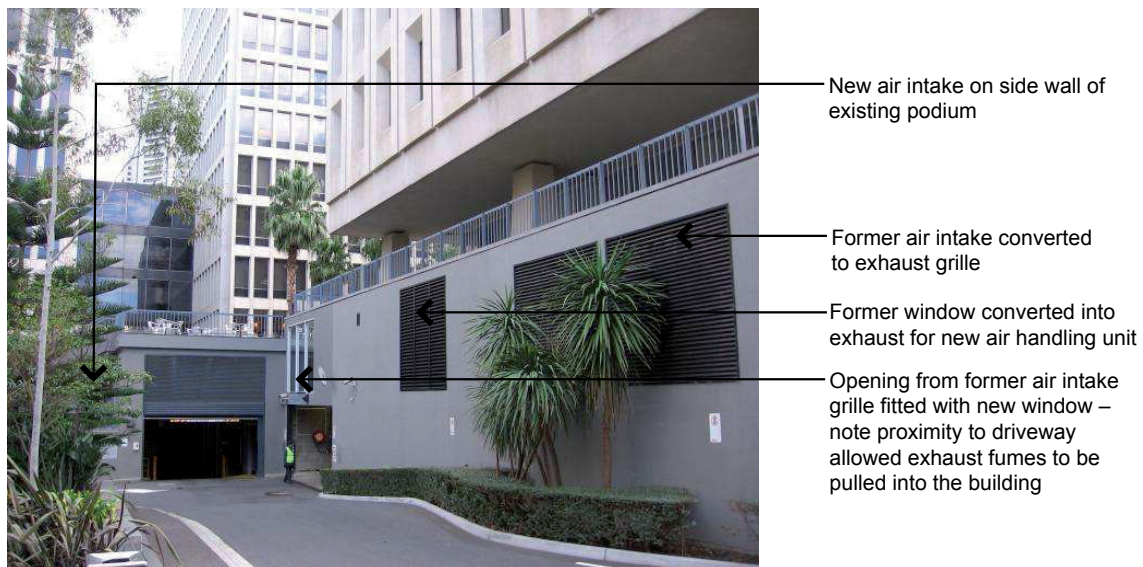
- cold air draughts and perceived lack of fresh air
- the outside air intake location resulted in it collecting exhaust fumes from vehicles in the adjacent driveway (causing more than one building evacuation in the past!)

**Figure 9. Former intake air grille location next to service road**

- The air-conditioning fresh air inlet was relocated to improve indoor air quality. This was previously located at the rear of the building in a position that sometimes brought vehicle exhaust fumes into the building from trucks using the service road.

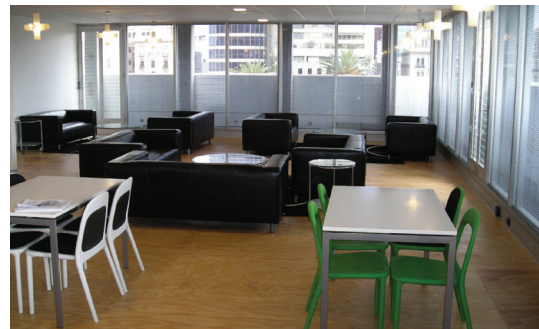
**Figure 11. Naturally ventilated resource room**

The concrete spandrel around the perimeter of the top floor raises the question – why was full height glass originally installed?  
(Source: Cundall, 2007)

- The design solution allowed for a naturally ventilated winter garden to be created at the northern end of level 4. This area is used as a meeting resource room, accessible to all building occupants.

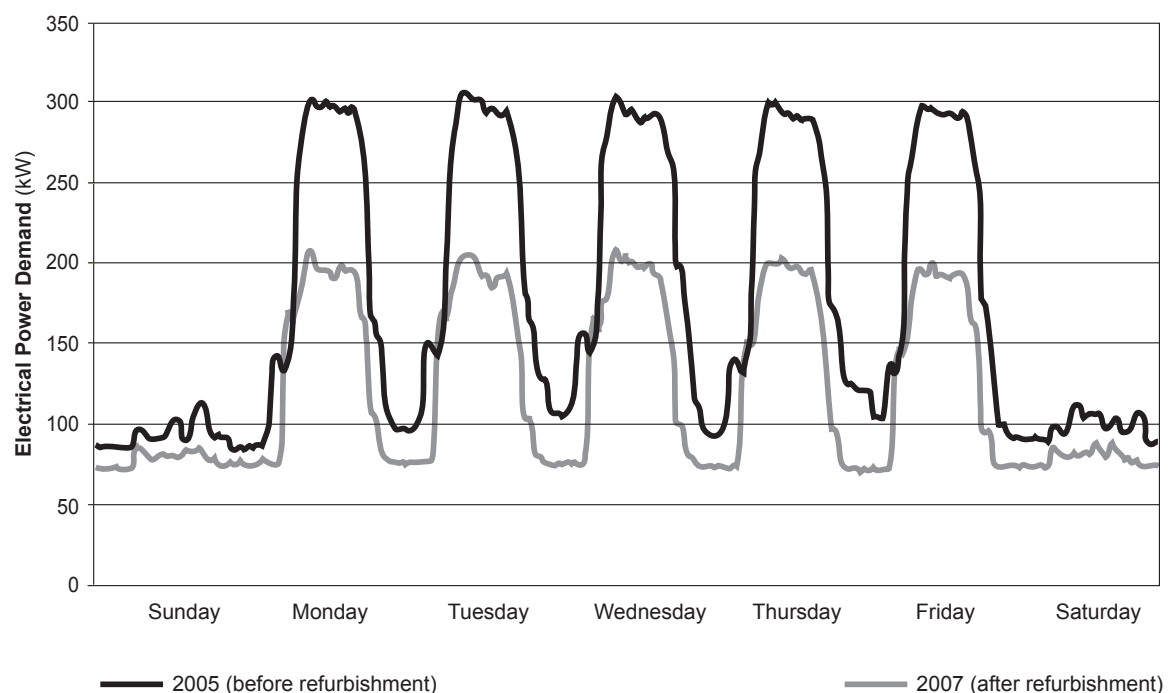
**Figure 14. Electrical efficiency gains**  
 Electricity profile for a typical week in August 2005 v 2007 (including data centre)  
 (Source: Cundall, 2007)
